**Moses Property Report
Eligible CDBG Uses
August 2023**

Combination
Lead-Based Paint Inspection
& Risk Assessment Report

for the Single-family dwelling located at:
136 State Street
Bowling Green, Kentucky

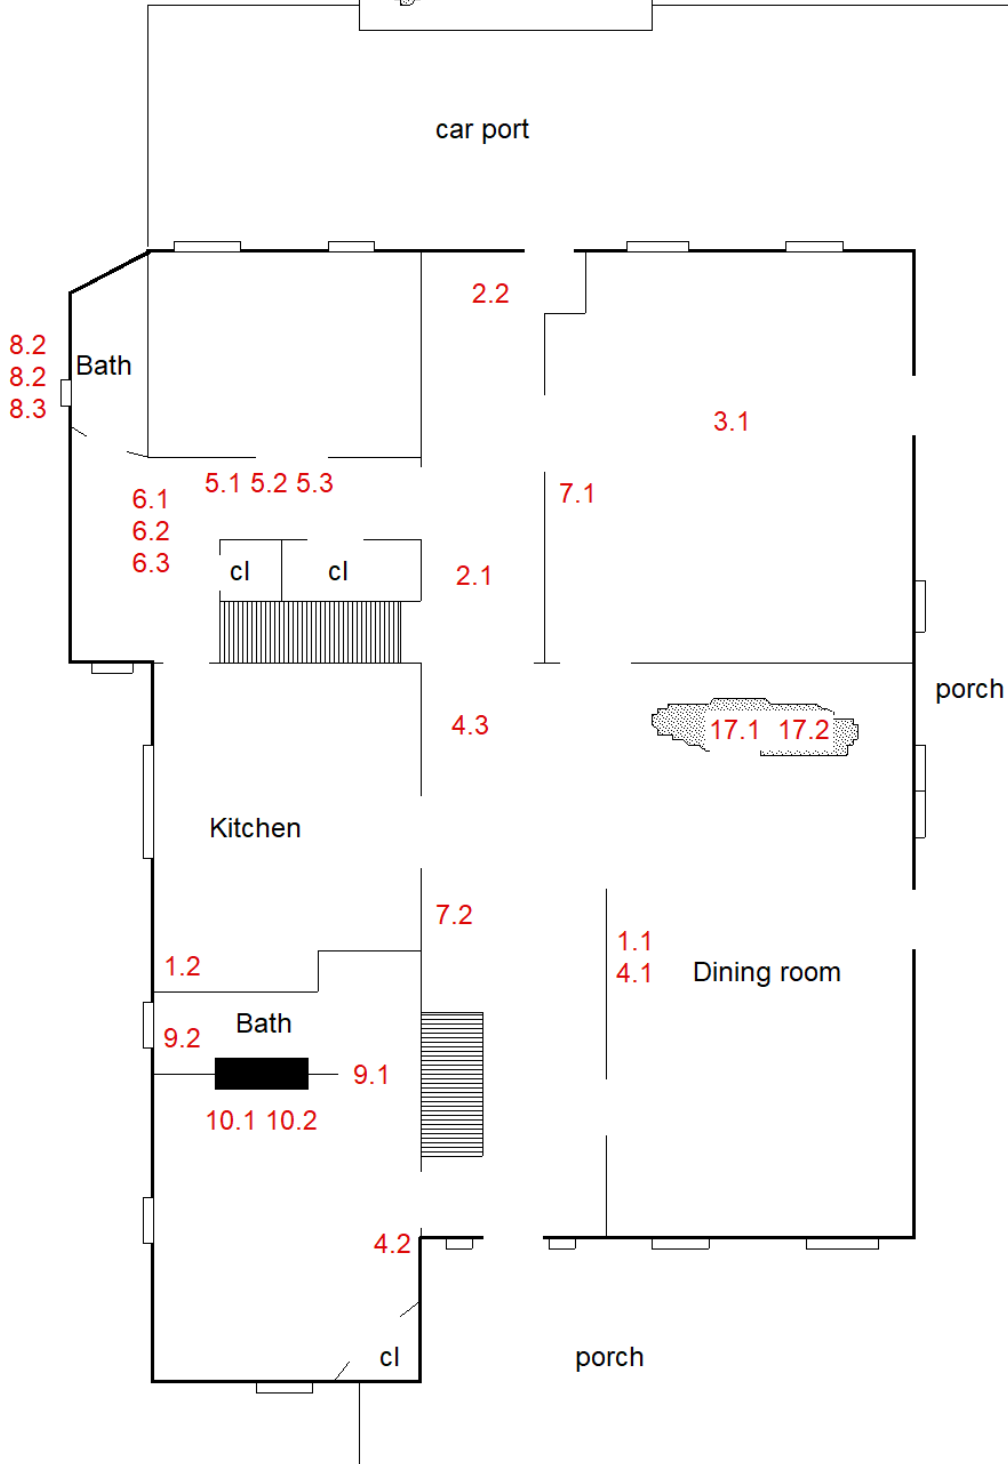
First floor

- transite debris

- ACM linoleum (HA-15)
- 3.2 - sample location

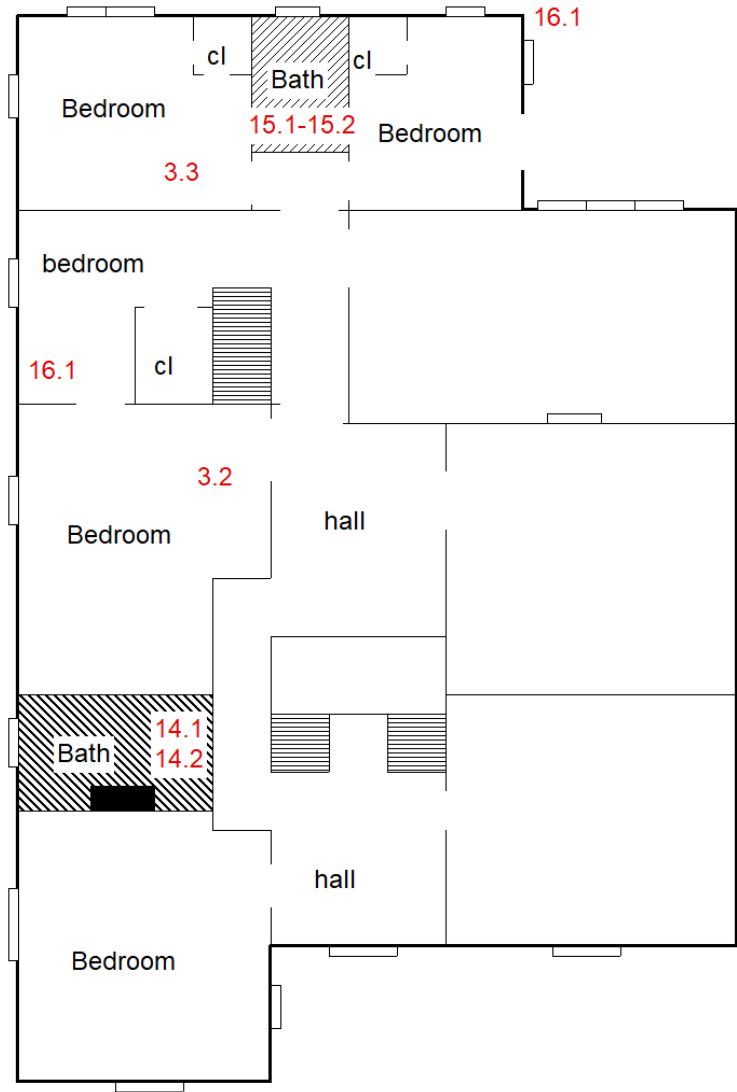
Second floor

- ACM pipe insulation
- 11.1 - sample location

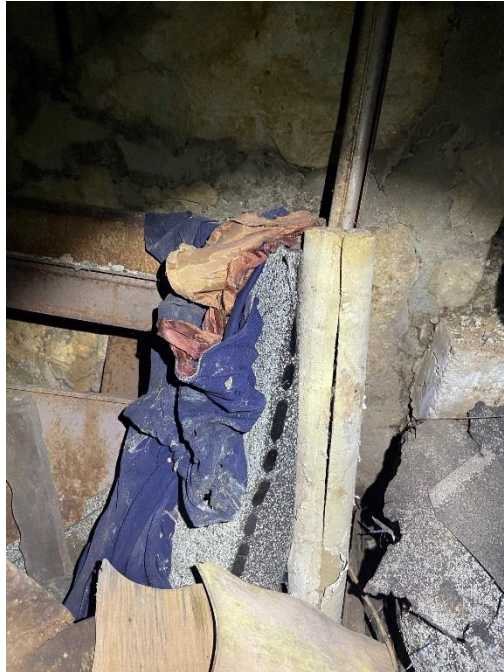
Photo 1. Pipe Insulation Debris.
Location: Basement next to the exterior door

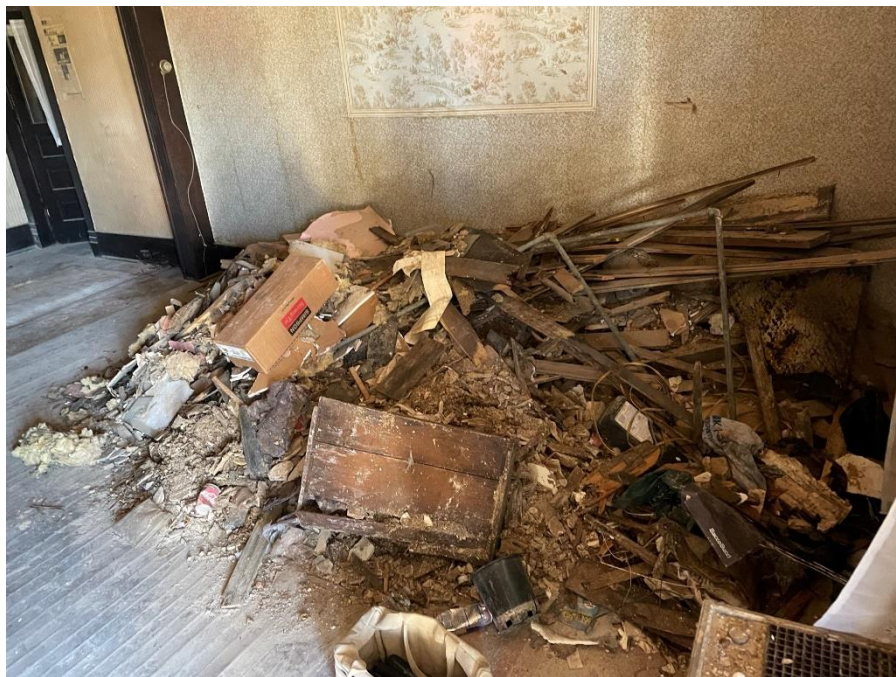
Photo 2. Pile of Debris with asbestos containing transite panels.
Location: Dining Room

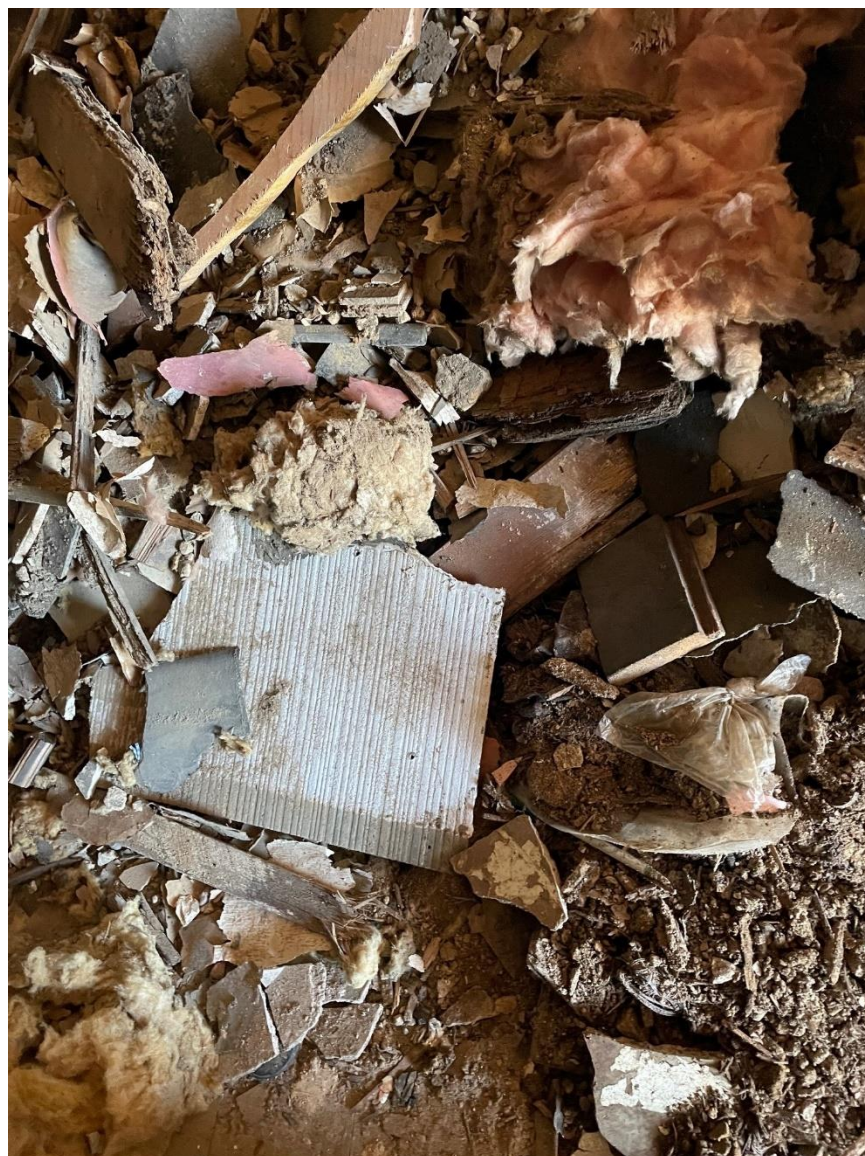
Photo 3. Asbestos containing transite panels.
Location: Dining Room debris pile
