**Moses Property Report
Eligible CDBG Uses
August 2023**

Combination
Lead-Based Paint Inspection
& Risk Assessment Report

for the Single-family dwelling located at:
136 State Street
Bowling Green, Kentucky

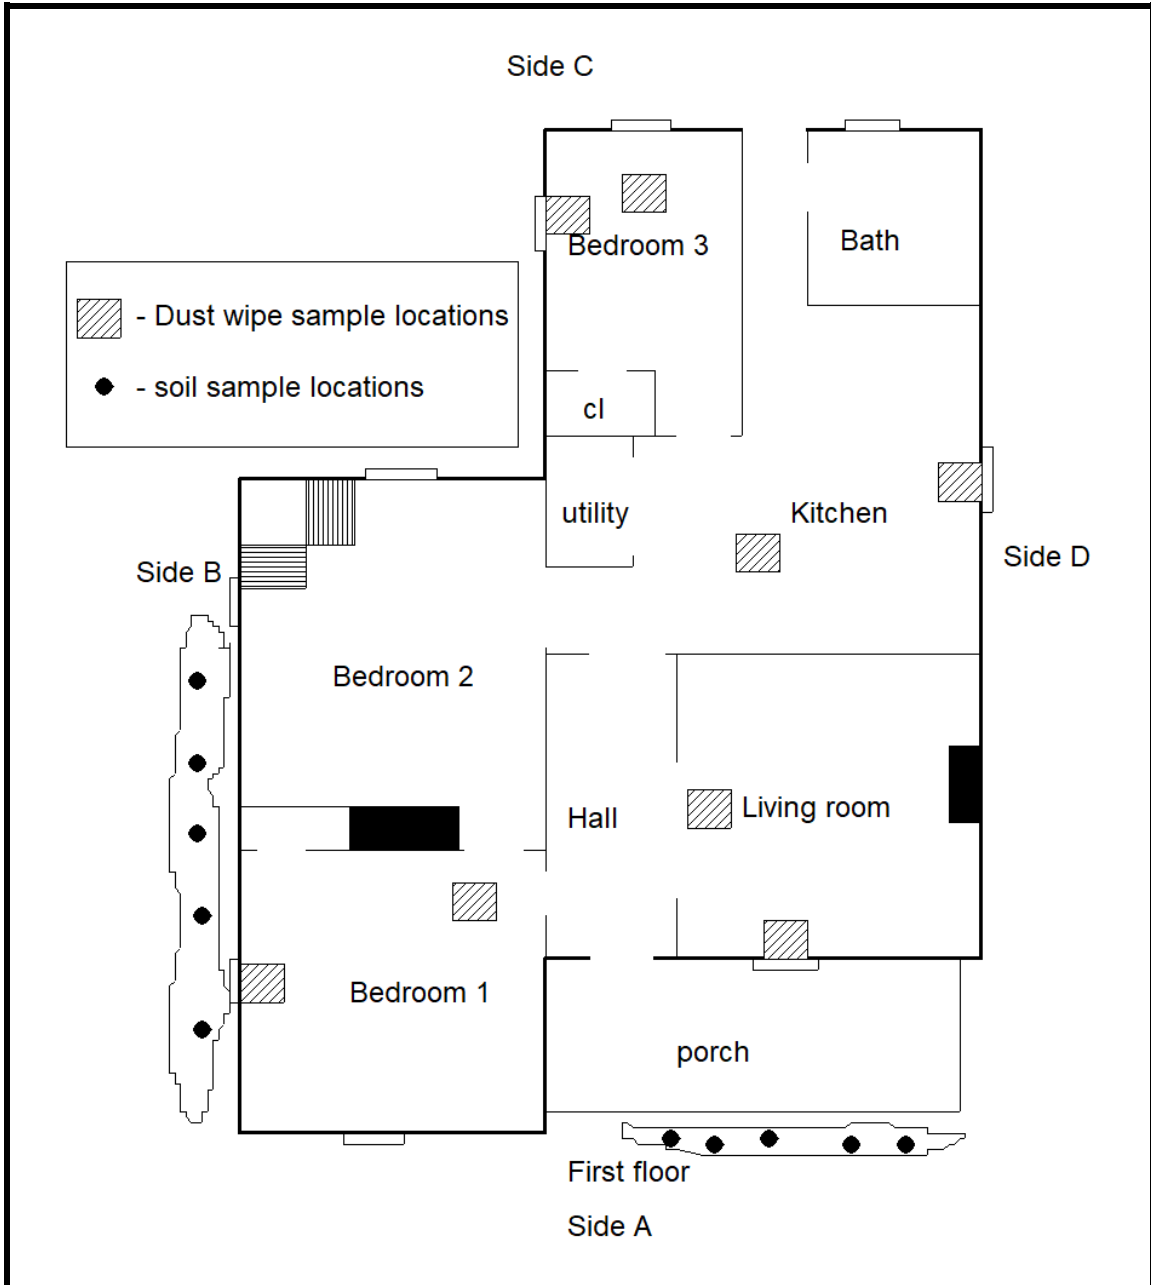
Floor Plan Drawings

Location of deteriorated paint hazards		
Location	Structure	Side
EXTERIOR	WALL (SIDING)*	ABCD
EXTERIOR	BUILDING SOFFIT*	ABCD
EXTERIOR	ORIGINAL WOOD WINDOW COMPONENTS	ABCD
EXTERIOR	PORCH CEILING, HEADER & SUPPORTS	A
HALL	BASEBOARD	ABCD
HALL	DOOR CASING	B, C & D
LIVING ROOM	BASEBOARD	ABCD
LIVING ROOM	DOOR CASING	B
LIVING ROOM	WINDOW SASH, CASING & SILL	A
BEDROOM 1	BASEBOARD	ABCD
BEDROOM 1	DOOR & CASING	C
BEDROOM 1	CLOSET DOOR & CASING	C
BEDROOM 1	WINDOW SASH, CASING & SILL	A & B
BEDROOM 2	BASEBOARD	ABCD
BEDROOM 2	DOOR & CASING	A & D
BEDROOM 2	WINDOW CASING	B & C

Location of friction surface hazards		
Location	Structure	Side
HALL	DOOR CASING	B, C & D
LIVING ROOM	DOOR CASING	B
BEDROOM 1	DOOR & CASING	C
BEDROOM 1	CLOSET DOOR & CASING	C
BEDROOM 2	DOOR & CASING	A & D

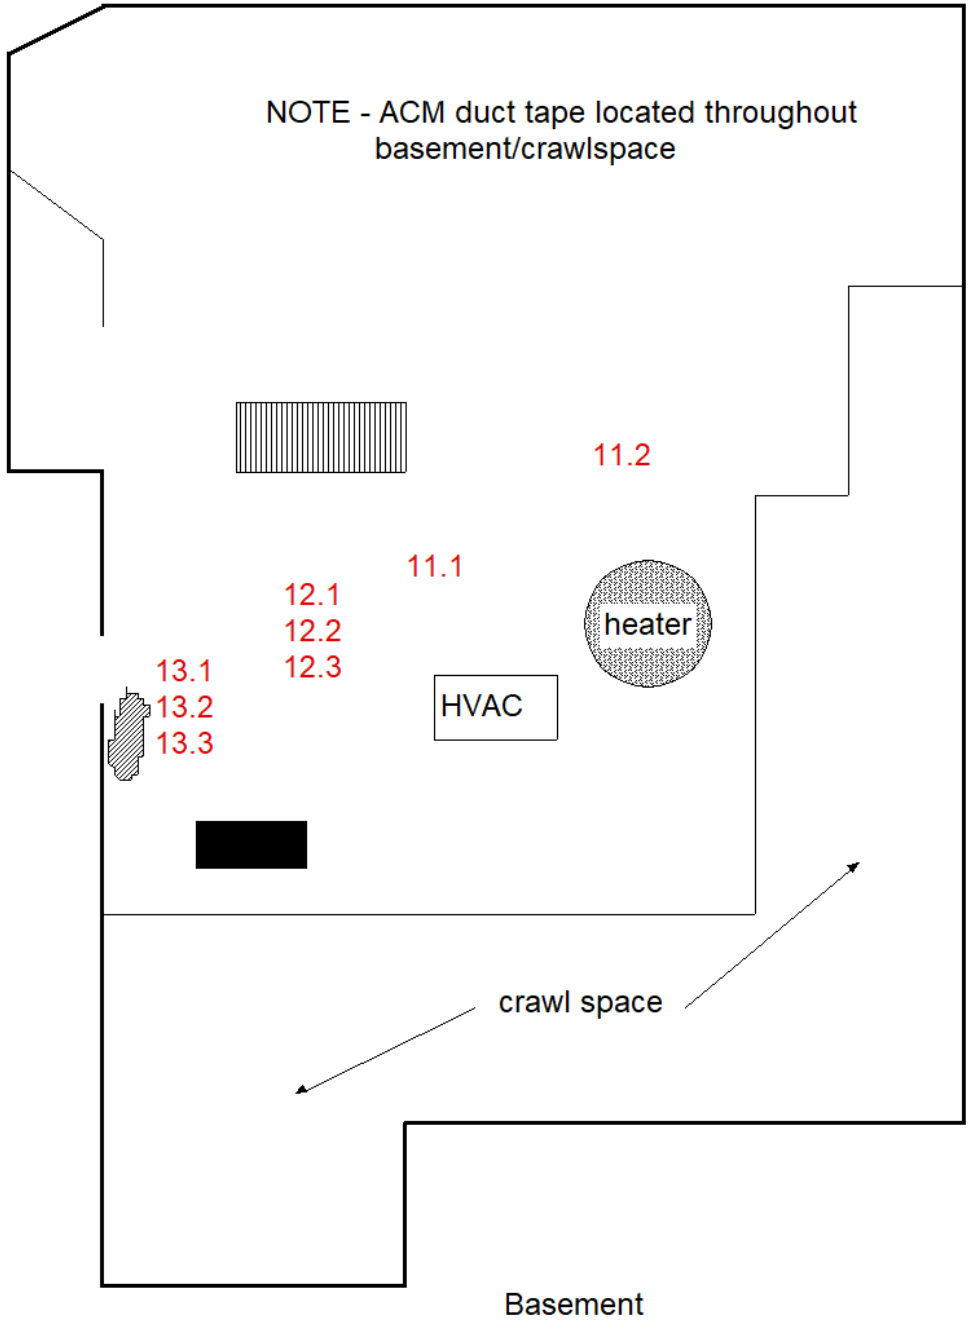
- ACM pipe insulation
- 11.1 - sample location
